Technical Memorandum

To: Shelter America Group – Christopher Bric **File Number:** 2617.0001
From: Alex Murphy, Soundview Consultants LLC **Date:** September 13, 2023
Re: Wetland, Stream and Fish and Wildlife Habitat Assessment and Buffer Modification Plan - 16816 95th Lane Southwest, Vashon, Washington 98070

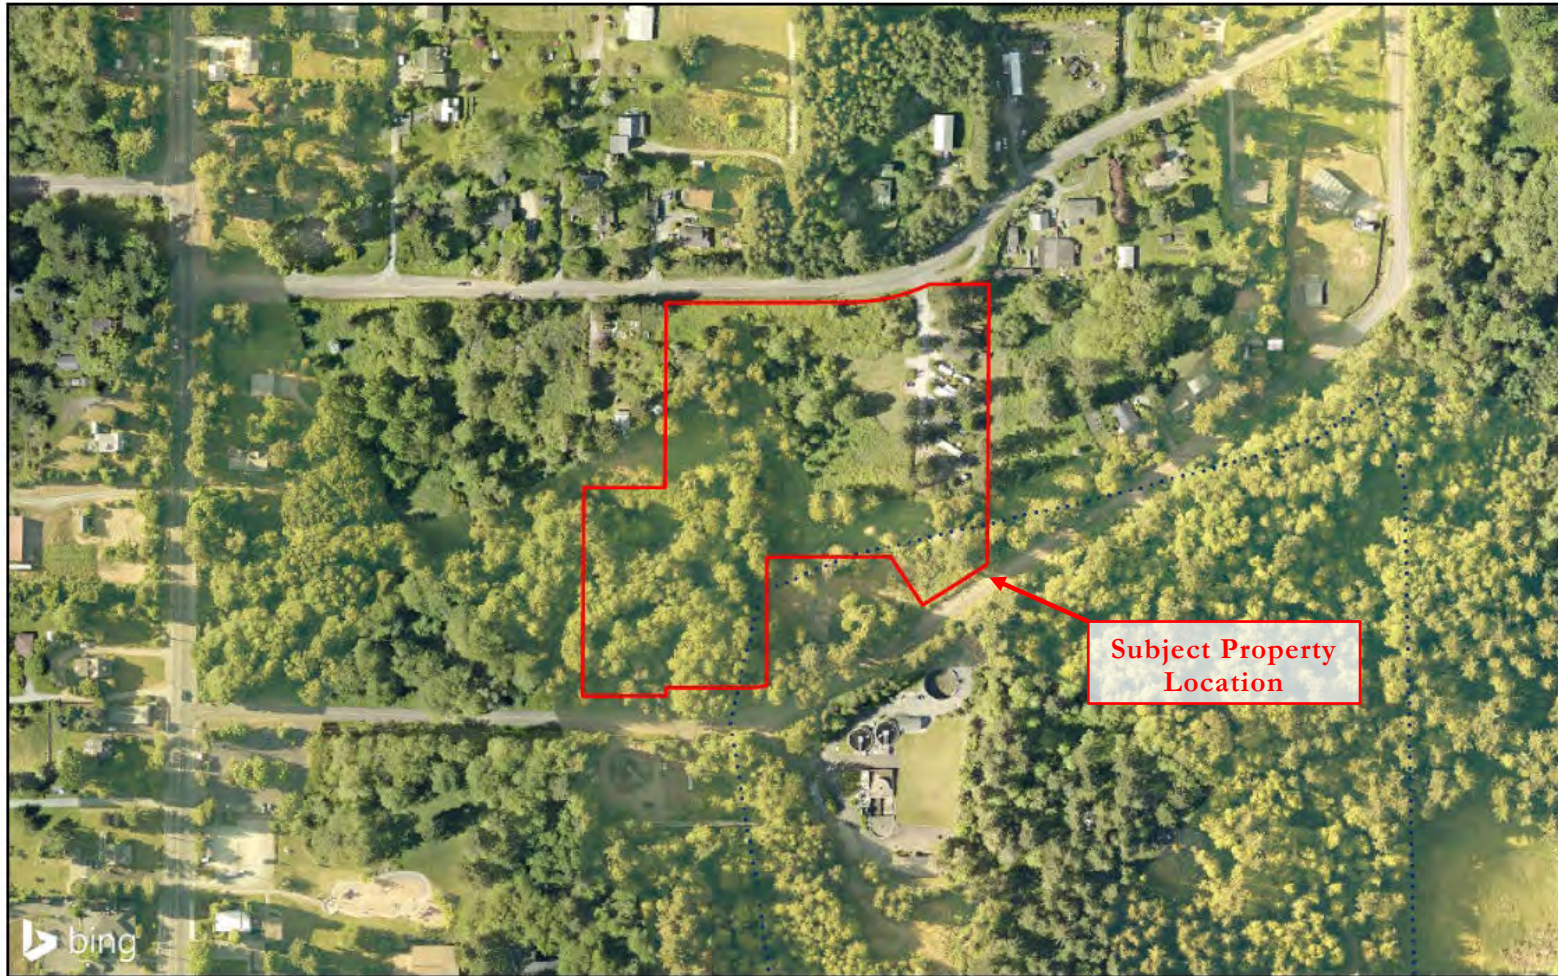
Attachment B1 – King County Stream and Wetland Inventory

The King County Streams and Wetlands Inventory (Attachment B1) identifies one potential unclassified stream entering the site from the south and flowing east offsite. USFWS NWI map (Attachment B2) identifies a stream in approximately the same location as King County and identifies a second potential stream entering the site from the west, flowing in an easterly direction, eventually flowing into the first stream. DNR stream typing map (Attachment B3) identifies potential streams in the same locations as NWI. The southern stream is identified as Type F and the western stream is identified as Type N. However, the WDFW PHS (Attachment B4) and WDFW and NWIFC SWIFD Map (Attachment B5) do not identify any potential streams or salmonid presence onsite. No potential wetlands are identified onsite by King County, NWI, or PHS.

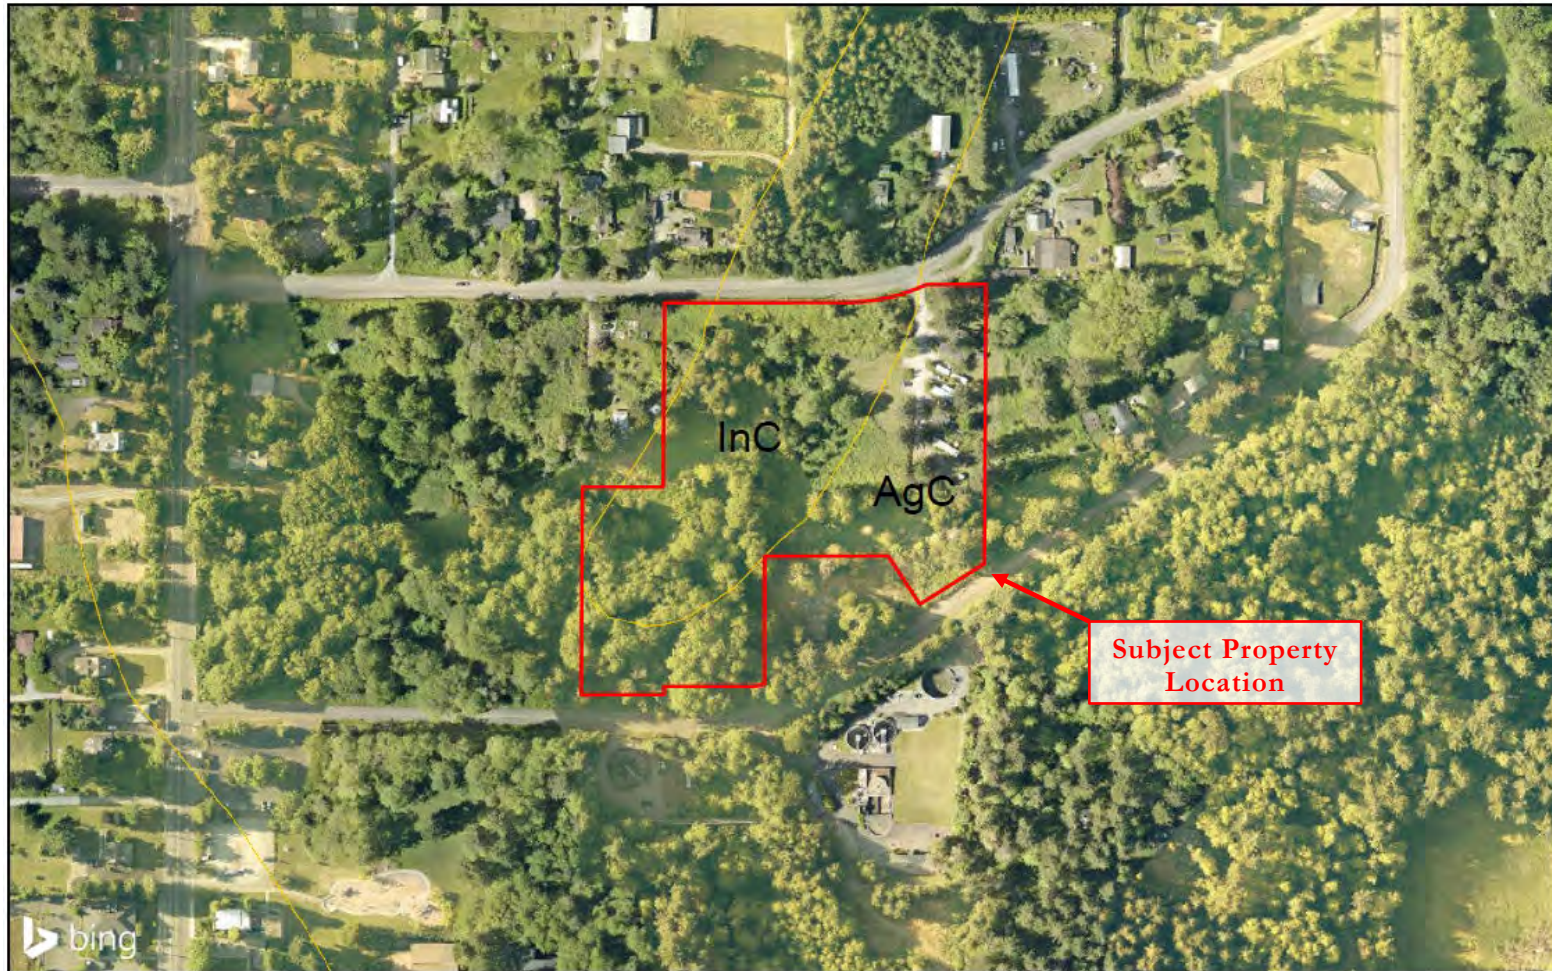
Attachment B6 – NRCS Soil Survey Map

The NRCS soil survey map (Attachment B6) identifies two soil series on the subject property: Alderwood gravelly sandy loam, 8 to 15 percent slopes (AgC) and Indianola loamy sand, 5 to 15 percent slopes (InC). According to the survey, Alderwood gravelly sandy loam, 6 to 15 percent slopes are moderately well-drained soil. Alderwood gravelly sandy loam, 6 to 15 percent slopes is listed as non-hydric on the King County Hydric Soils List, however it can contain up to 5 percent inclusions of the hydric soils Norma sandy loam and Shalcar muck (NRCS, n.d). According to the survey, Indianola loamy fine sand, 4 to 15 percent slopes, is an undulating soil with convex slopes near upland terraces. Indianola loamy fine sand, 5 to 15 percent slopes, is listed as non-hydric on the King County Hydric Soils List, but may contain up to 2 percent hydric inclusions of Norma silt loam (NRCS, n.d).

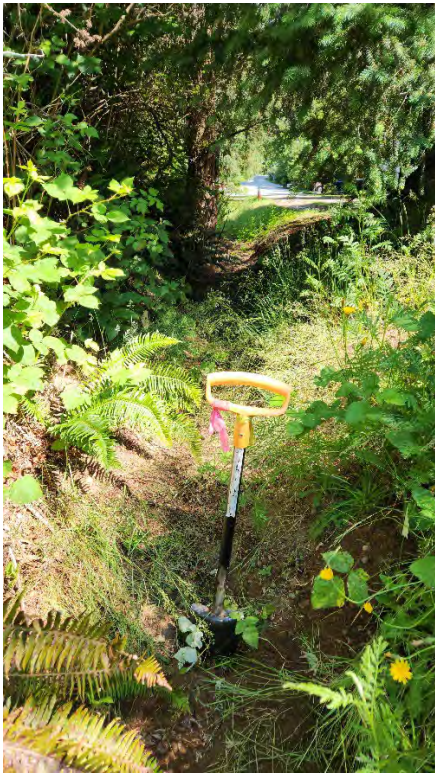
SVC identified three likely unregulated drainages (Drainage Z, W, and X) onsite. All drainages failed to meet the required characteristics to be considered streams under the WAC or aquatic areas under KCC. Drainage X is located upgradient and west of Stream Z and was dry with evidence of ephemeral flows during the wet season or during and immediately following precipitation events. Drainage X shows evidence of overland flows visible through minor sorting but lacks a defined bed and bank. Drainages W and V were identified using LIDAR data, as they were located over 300' away from the proposed development. Drainage W is located west of Wetland A, conveying surface flows into the wetland. SVC observed a clear separation in vegetation at the intersection of the drainage and wetland boundary, supporting the boundary as flagged onsite. Drainage V enters the property from the west, extending southeast before flowing into Stream Y.

Drainage feature along DP-1

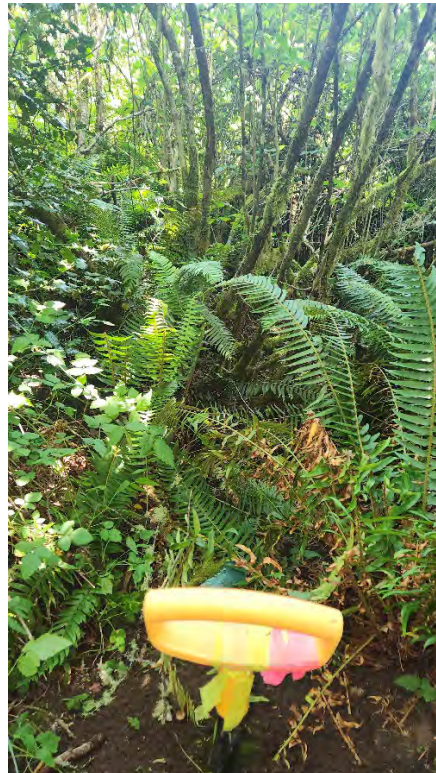
Vegetation on the subject property is characterized by patches of forest and discrete patches of dense non-native invasive Himalayan blackberry (*Rubus armeniacus*). The forested areas consist of red alder (*Alnus rubra*) and Douglas fir (*Pseudotsuga mensiezi*) with an understory of osoberry (*Oemleria cerasiformis*), salmonberry (*Rubus spectabilis*), stinging nettle (*Urtica dioica*), trailing blackberry (*Rubus ursinus*), and western swordfern (*Polystichum munitum*). Non-native English ivy (*Hedera helix*) is prevalent in forested sections to the southeast where shaded conditions prevent Himalayan blackberry from growing. Abandoned orchard trees, including various apple (*Malus spp.*) and cherry (*Prunus spp.*) trees are present in the vicinity of the mobile homes.

General Upland Conditions

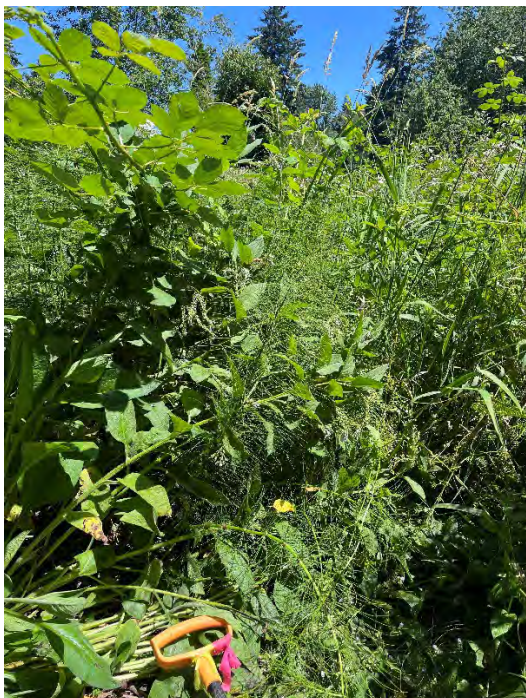
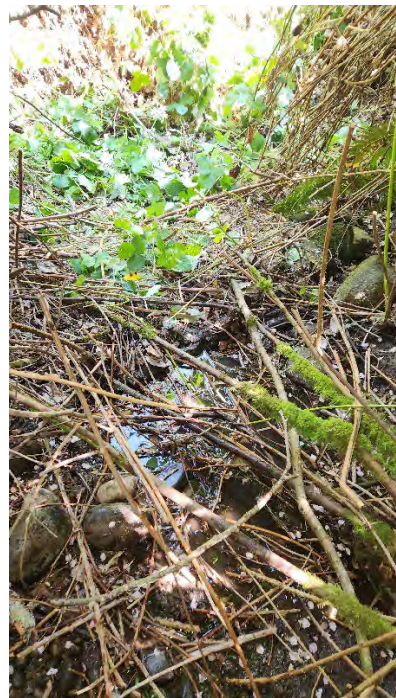
Confluence between Stream Z and Stream Y

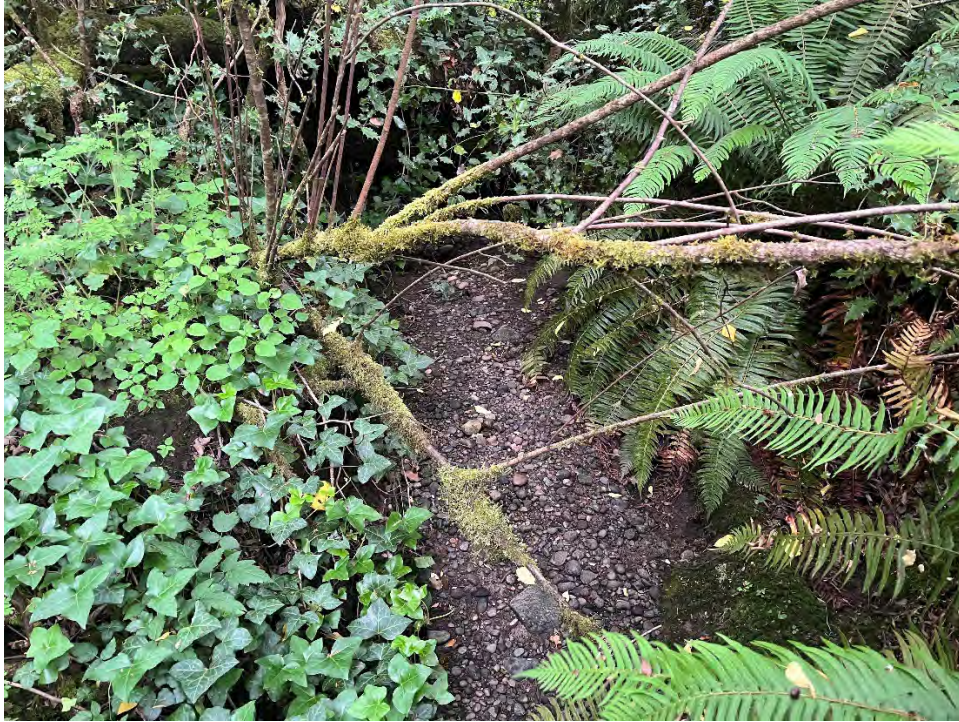
Stream Z

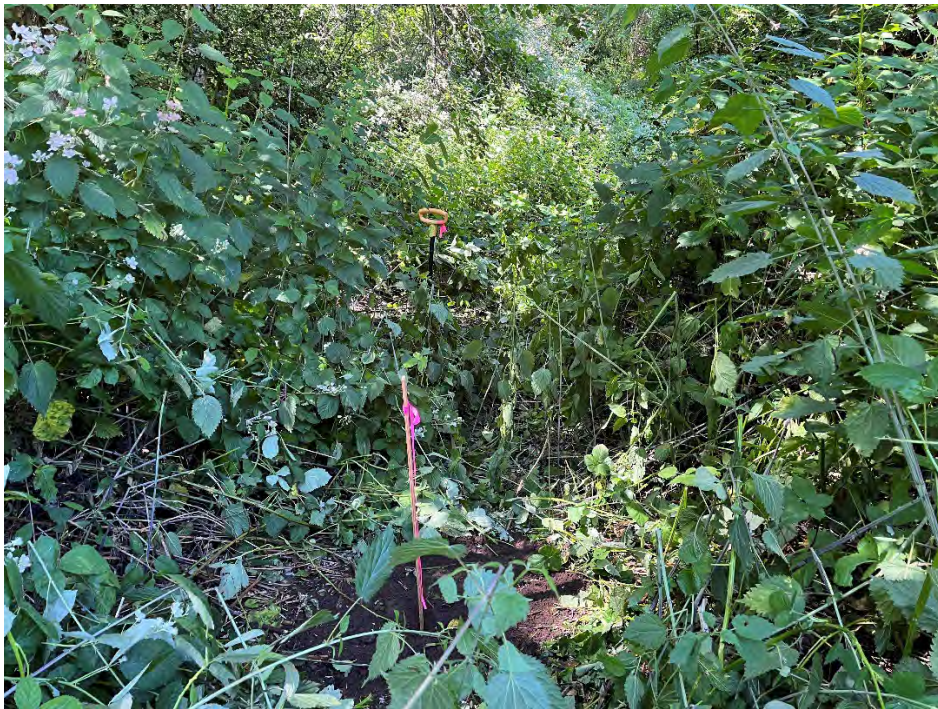
General Upland conditions along DP-4
