Annual Bridge Report

King County
Department of Local Services
Road Services Division

August 2023

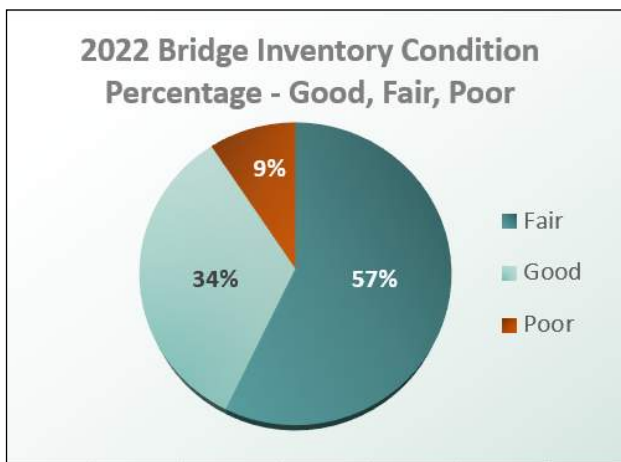
The adjacent chart below shows the number of vehicular bridges in each category. In year 2022, there are 17 bridges (9 percent) categorized in the state of “poor”, 103 bridges (57 percent) in Fair and 61 bridges (34 percent) are in “Good” A bridge in poor condition has advanced deficiencies such as: section loss, deterioration, scour, or seriously affected structural component. Due to these deficiencies, these structures may have weight restrictions. It is likely that the bridges in the “fair” category may fall into the poor category if the assets are not managed with proper maintenance.

Condition state percentage totals exclusively for Roads timber bridges are, 76 percent in “fair”, 24 percent in “poor” and none in condition state “good”.

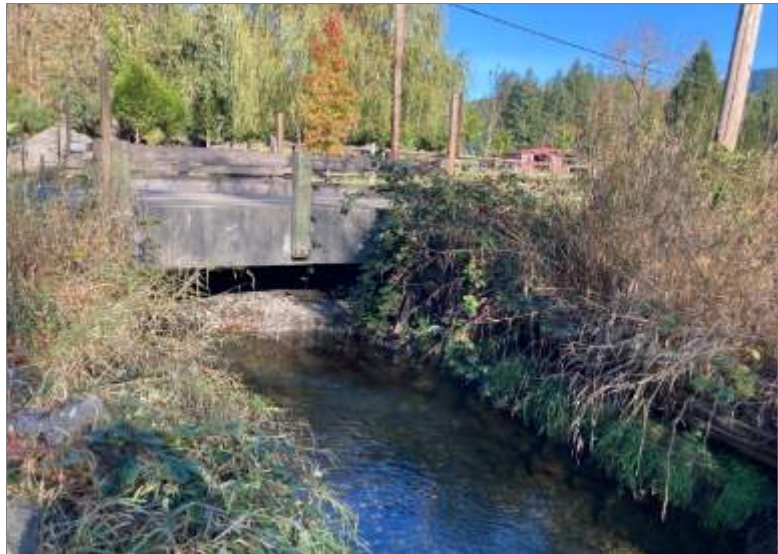
Located north of the city of North Bend, this short span sole-access bridge carries SE 73rd Street over Tate Creek. The hydraulic opening under the bridge is very limited. Sediment accumulation at the bridge reduces the hydraulic opening under the bridge, which causes overtopping of the approach roadway and results in the isolation of 200-plus residents in this neighborhood during flood events.

Tate Creek Bridge No. 122N – Looking North

A feasibility study is proposed to determine the best scope of the project as the bridge is located on a substandard horizontal alignment with additional sight distance and private property owner impact challenges. Partial funding is available with Flood Control District funds to start the initial study phase in 2023.

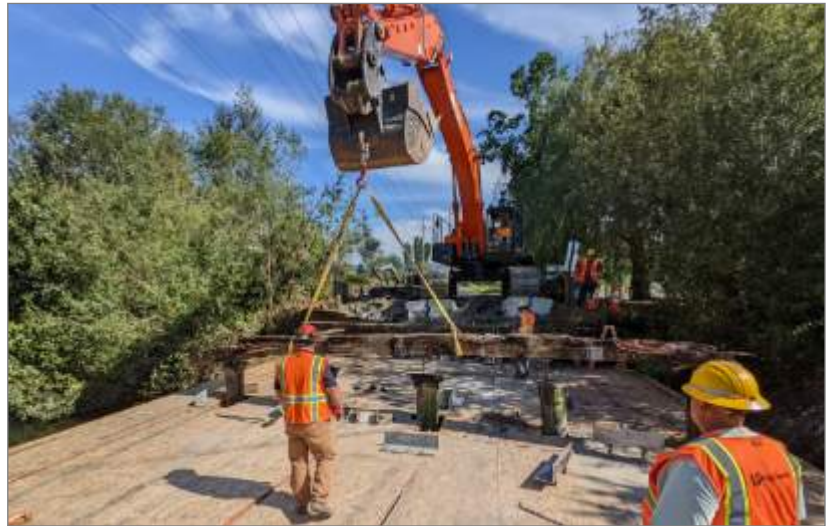
During the routine inspection in late June 2022, inspectors found advanced rot in the timber caps which resulted in closure of the bridge until repairs could be implemented. This was a “critical finding” per 23 CFR 650.31.3(h), which required filing a Critical Finding Damage Report (CFDR) to WSDOT and FHWA in a timely manner.

Newaukum Creek Bridge No. 3063 – Removing decayed timber caps from a work platform

Repairs consisted of replacing the timber caps, removing and resetting concrete multi-web girder and bridge rails, and repaving approaches and bridge deck with new asphalt. This project was completed in October 2022.

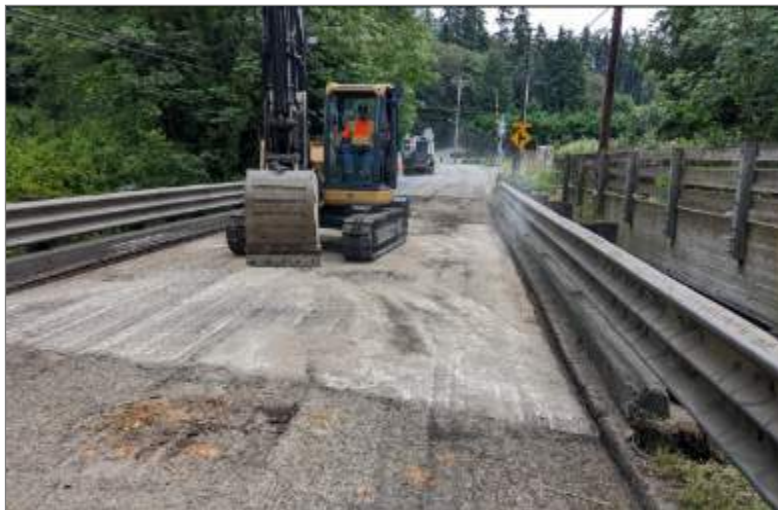
Covington Bridge No. 3085

Covington Creek Bridge No. 3085 – Removing asphalt surface down to the concrete slab

The poor condition of the concrete deck caused recurring potholes in the asphalt overlay, creating a rough ride across the bridge for vehicles. A patchwork of asphalt repairs over the years failed to address the root cause. A full bridge closure on this busy road was required to properly repair the bridge deck. The

concrete deck spalls and delamination were repaired, and an asphalt overlay was applied. Some needed rail repairs were also completed while the bridge was closed to traffic.

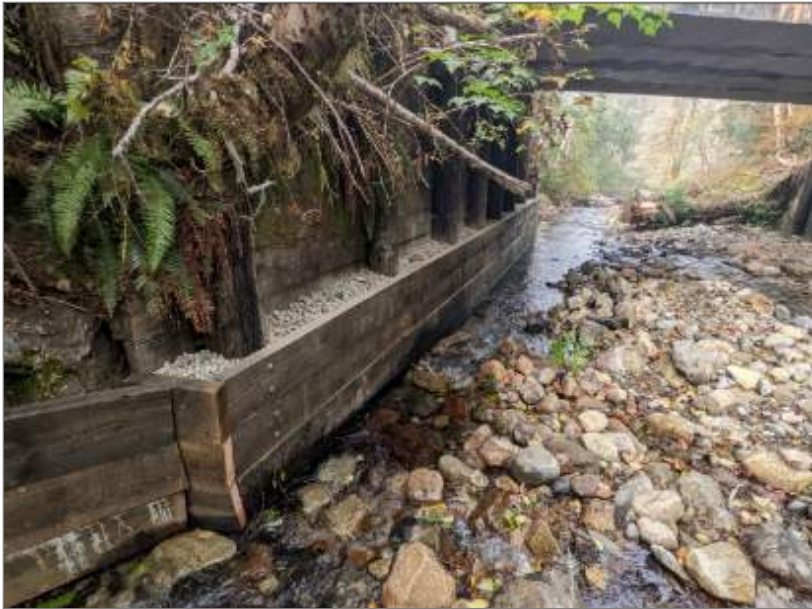
Granite Creek Bridge No. 359A – Fender wall added to protect the abutment backwall from scour

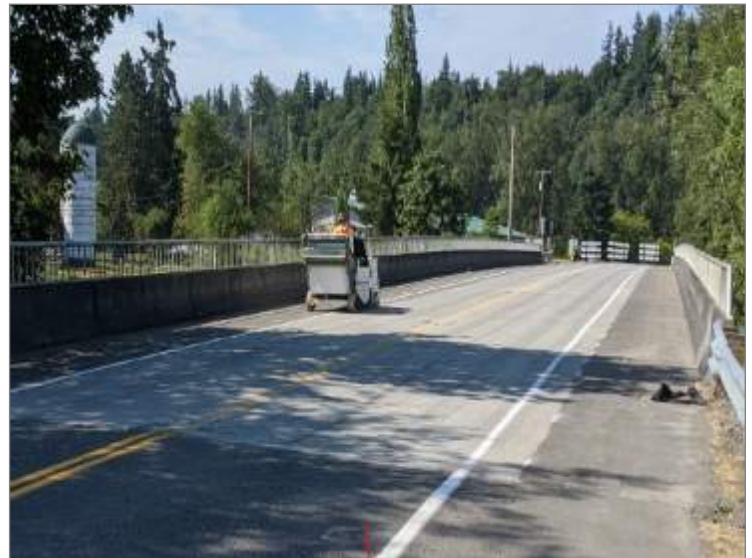
The concrete deck had developed transverse cracks with aggregate pop-outs that are typical pre-cursor signs of accelerated deterioration of concrete decks. A new epoxy overlay wearing surface was applied with two layers of sand to protect and seal the deck from further deterioration. The addition of the overlay is estimated to add another 15-20 years to the life of the bridge deck.

Whitney Bridge No. 3025 – Shotblaster preparing the deck for application of epoxy overlay

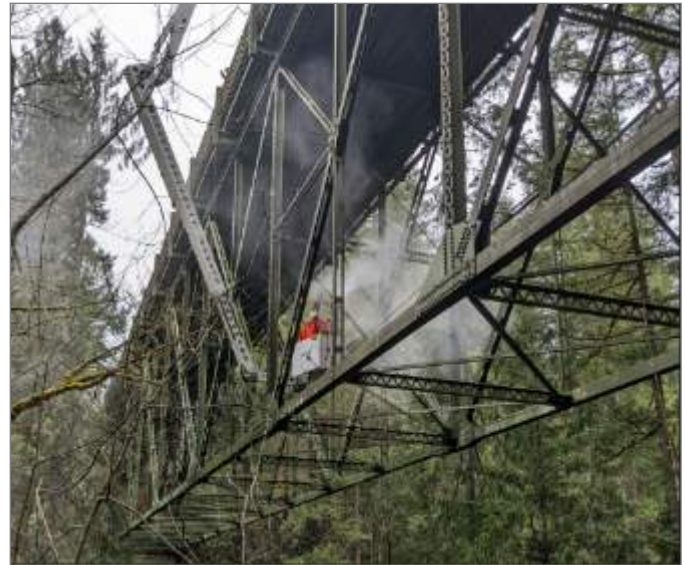
The first bridge listed is a movable steel truss bridge on a routine five year washing cycle, the next two bridges are built of both concrete and steel that are washed as needed when dirt and moss accumulation obstruct the ability to visually inspect the concrete and steel components. The last bridge is a concrete structure in a high visibility area with heavy pedestrian use and art elements.

Washing lower truss members of the Green River Gorge Bridge No. 3032 in January 2023

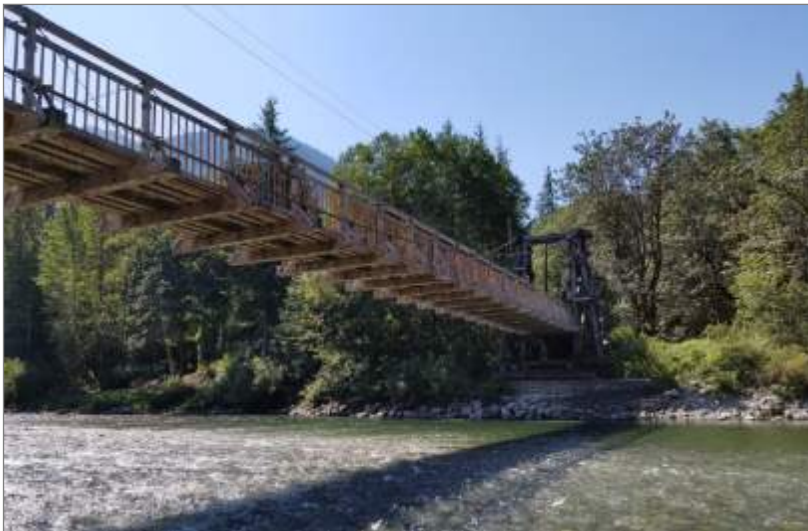
Baring Bridge No. 509A – South tower and timber truss of suspension bridge spanning the Skykomish River

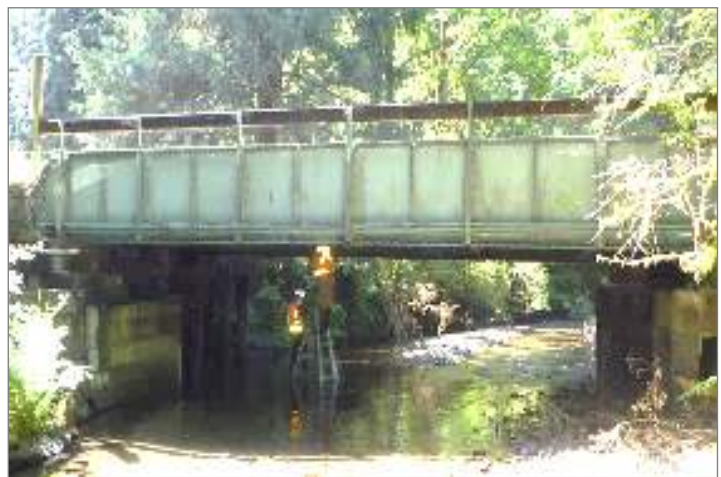
Coal Creek Bridge No. 3035A – South elevation

The bridge is 18 feet wide. The steel girders and floor beams of this bridge are over 100 years old; they were originally in place at another bridge location in 1912 and moved to this site in 1958. In addition to the severely corroded steel and limited load capacity, other deficiencies include deteriorating creosote timber piles, rotten timber backwall planks, substandard rails, and downstream bank erosion. The sufficiency rating is 6 out of a possible score of 100. The bridge is scheduled to be inspected every three months to monitor the advanced section loss progression.

Roads was awarded federal funding in November 2017 and funding was obligated and authorized in May 2018 to proceed with design for the project. The project design was completed in early 2021, and the construction contract was executed in Summer 2021. However, due to Covid restrictions and the extended time of procuring materials for the project, the primary construction did not start until 2022 and construction is planned to be completed in 2023.

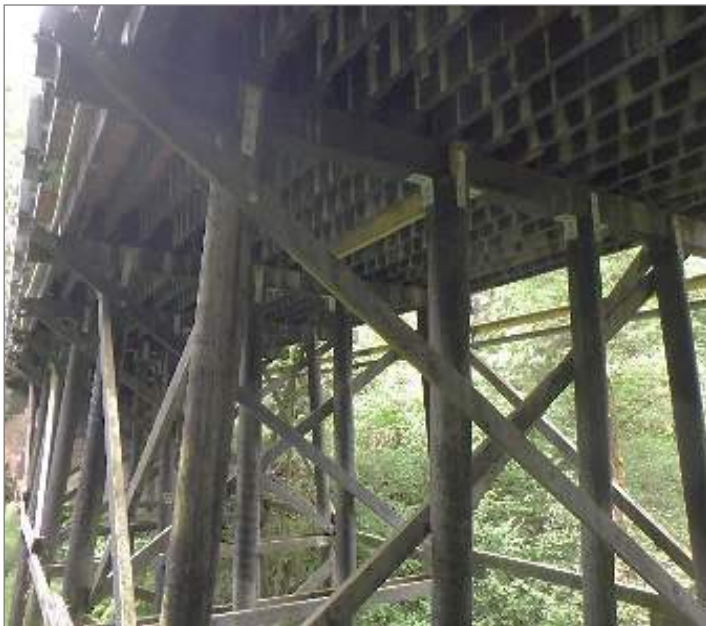
Ames Lake Trestle No. 1320A – Timber structure

for current needs. The 98-year-old timber substructure is beyond its useful life and there are no cost-effective solutions for repairing or rehabilitating that could provide the necessary additional load capacity.

A consultant design contract was executed in June 2019 to perform a TS&L analysis and preliminary design. This work was completed in July 2020 resulting in a selection of a preferred alternative for advancement to final design phase. An amendment for the final design phase was executed in October 2020. The 60 percent design was completed in May 2021, and the 90 percent design was completed in February 2022. The 100 percent design is scheduled to be complete by summer 2023 and construction is planned for 2024.

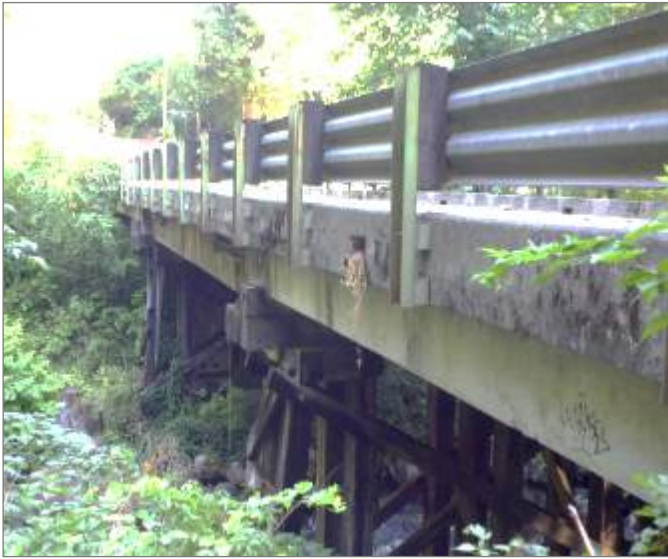
Upper Tokul Creek Bridge No. 271B – Timber substructure supporting concrete deck units

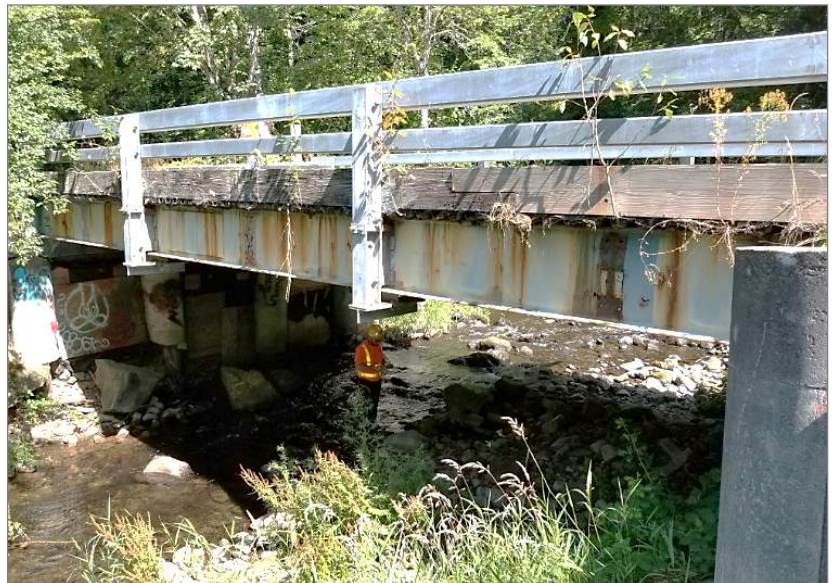
Boise X Connection No. 3055A – Southwest elevation

The bridge deck is narrow (21 feet from curb to curb), with no shoulders or sidewalks. The asphalt driving surface is supported by a corrugated metal decking system. Deficiencies of the main structural members include corrosion of the corrugated metal decking, corrosion of the steel girders, extensive rot at one of the timber caps, and piles with extensive concrete encasement repairs. The bridge is considered scour critical, and the creek has undercut approximately two feet below the concrete encasement repairs. In addition, most of the timber abutment is in poor condition. The backwall planks are rotten and were repaired with plywood to retain the roadway fill.

In December 2019, the bridge was awarded federal funding for design and construction of a bridge replacement. The federal funding was obligated and authorized to proceed with design in May of 2020. Construction is planned for 2025.

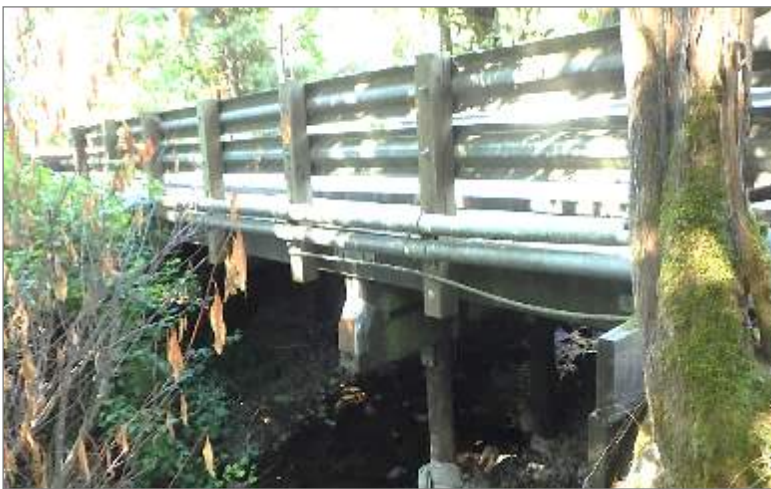
Fifteen Mile Creek Bridge No. 493C – South elevation of timber substructure and stringers

A federal grant for the design and construction was awarded in December 2019. The federal funding was obligated and authorized to proceed with design in May of 2020. Design and permitting is currently at the 99% complete with remaining effort being concentrated on right-of-way agreements. Replacement construction is planned for summer 2025 and involves a full road closure for the duration.

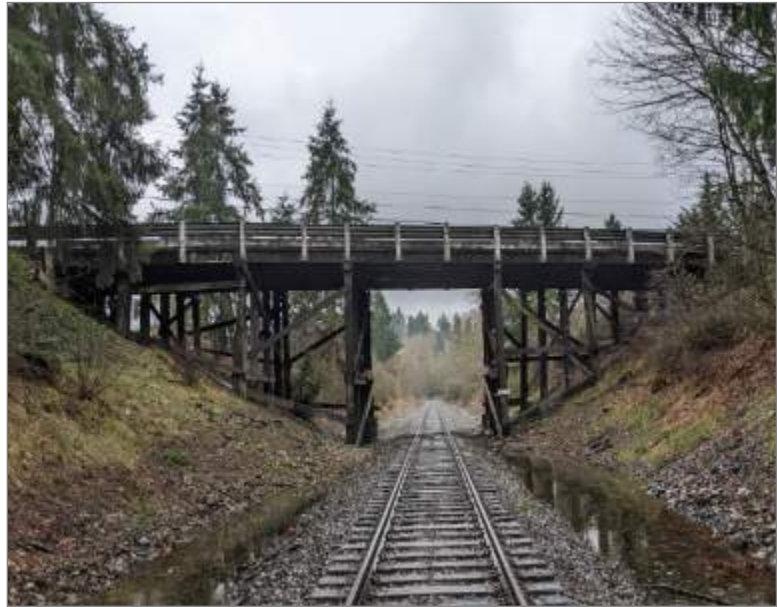
The Berrydale Overcrossing Bridge carries Kent-Black Diamond Road, which is a high-volume arterial, over the Burlington Northern Sante Fe (BNSF) Railroad corridor. It has a posted speed limit of 40 miles per hour. The bridge deck is very narrow (22 feet from curb to curb), with no shoulders or sidewalk. It also has substandard rails and substandard sight distances due to the vertical curve of the roadway. The bridge is structurally deficient with a sufficiency rating of 20.69 out of a possible score of 100. The bridge is past its useful service life, and requires frequent, major, and costly repairs. It is built fully with timber components.

Berrydale Overcrossing No. 3086OX – Looking south near the BNSF rail-line

Although full funding for replacement of the bridge and its approach roadway is uncertain, because of the criticality of this corridor, initial preliminary feasibility study work was funded in the 2017-2018 Roads Operating Budget. The project is complex as it involves coordination with BNSF Railway, a difficult vertical curve sight distance issue, and construction impact to the traveling public. A planning level Concept Feasibility Study report for a replacement structure was completed in 2022. A grant request was subsequently made to the Puget Sound Regional Council (PSRC) Surface Transportation Program (STP) in 2022 for the Design phase. The recommended scope includes construction of two roundabouts, replacement of Jenkins creek fish passage culvert and replacement of Berrydale overcrossing structure over BNSF railroad.

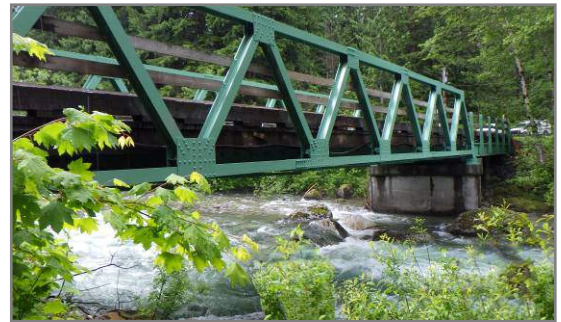
Foss River Bridge No. 2605A

Built in 1951, spanning a tributary to the Skykomish River in northeast King County. This warren pony truss was added to the National Historic Registry in 2002.

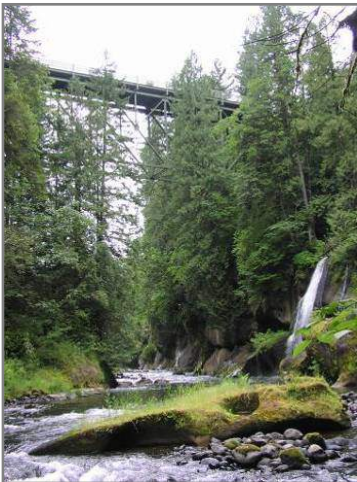
Green River Gorge Bridge No. 3032

Built in 1914, spanning the Green River Gorge in southeast King County. This is a rare and intact example of the Baltimore Petit deck truss structural design. The Green River Gorge Bridge is the only Baltimore Petit deck truss bridge owned and maintained by King County. Designated in 2004.

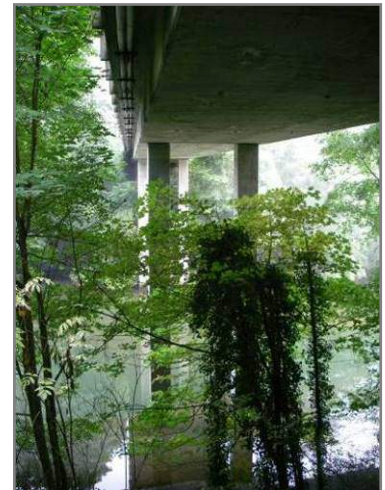
Judd Creek Bridge No. 3184

Built in 1953 on Vashon Island, it carries SW Vashon Hwy over Judd Creek. It is a concrete hollow-box (box girder) bridge designed by Homer M. Hadley. Designated in 2004.

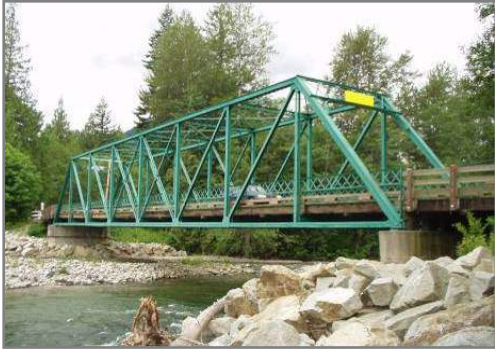
Miller River Bridge No. 999W

Built in 1922, it carries the Old Cascade Scenic Highway over Miller River. This riveted Pratt truss is located near the community of Skykomish. Designated in 1999.
