In-Line Ditch Stormwater Treatment BMP Program

Final Report

King County
Department of Transportation
Road Services Division
Roads Maintenance Section

Stormwater Management
Implementation Grant Program

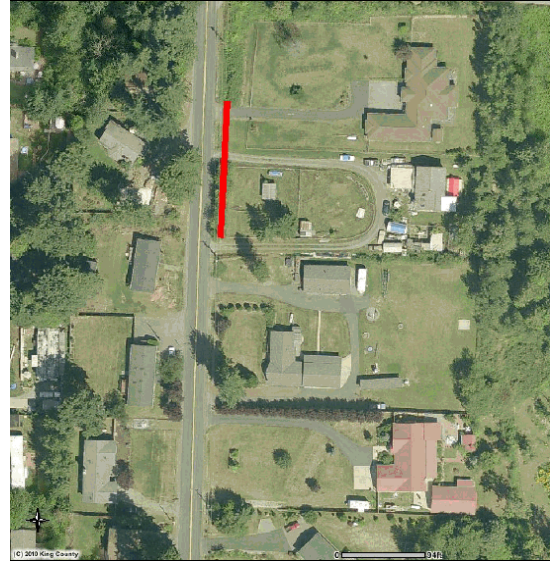
Figure 2. Project 148 watershed

Project 148 is located in a ditch running along the east shoulder of 148th Ave SE (Figures 2 and 3), a collector – arterial road just south of SE 102 St as shown in Figure 2. The ditch drains an area north of SR 900 and east of 148th Ave SE that is dominated by rural residential properties. The road is crowned, has a with very limited shoulder and stormwater flows directly from the road surface into the ditch. The ditch flows to the north, draining to May Creek. The roadway has a moderate average daily traffic (ADT) volume of approximately 2,000 vehicles and has narrow shoulders on the ditch side of the road. Three water quality BMPs were installed in the spring of 2009 for monitoring during the 2010 water year.

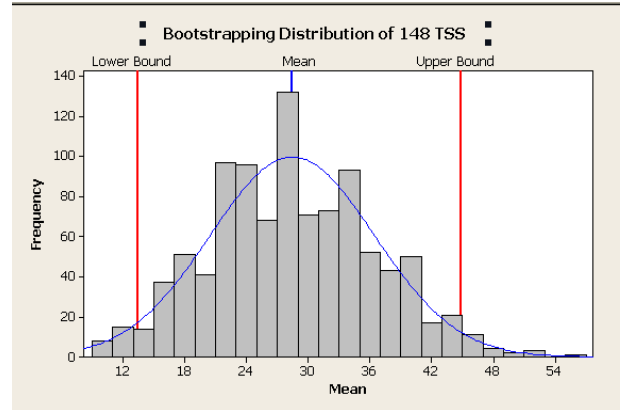
Figure 11. Bootstrapping Example. Histogram distribution of Project 148 influent TSS is shown on the left, the bootstrapping distribution (1000 iterations) of the same data set is shown on the right.

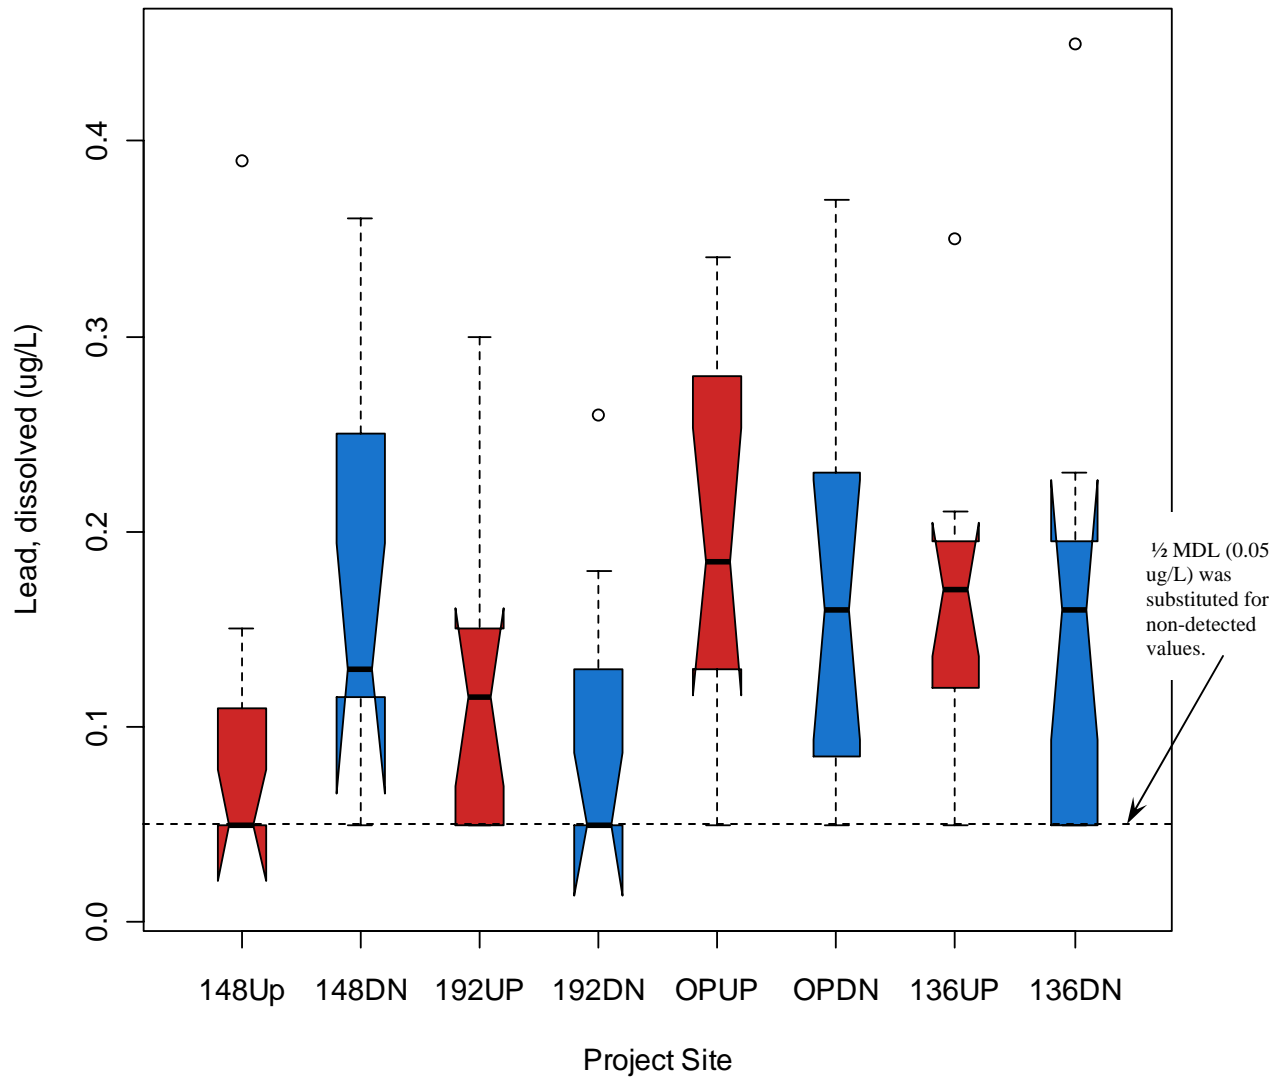
Figure 24. Lead, dissolved (ug/L)

Lead, dissolved results include values reported at below the MDL of 0.1 ug/L. This graphic was prepared using one-half of the MDL (0.05 ug/L) as a placeholder for these <MDL values.

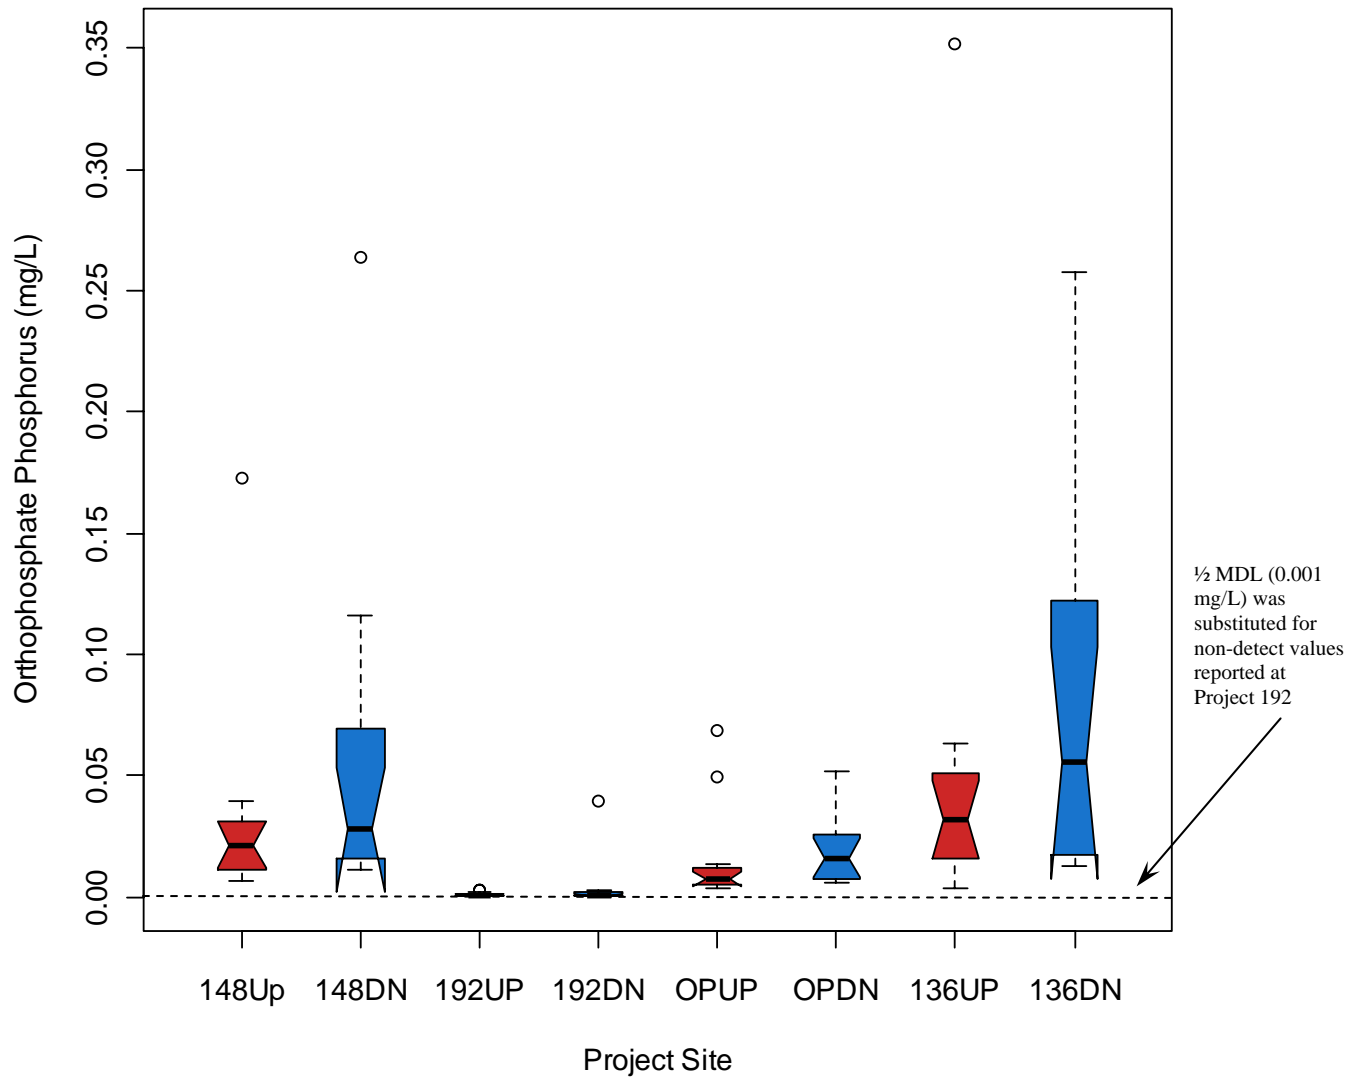
Figure 31. Orthophosphate phosphorus (mg/L)

Orthophosphate phosphorus results for Project 192 include values reported as below the MDL of 0.002 mg/L. A substitution of 0.001mg/L (1/2 the MDL) was used for values at Project 192 reported as <MDL.

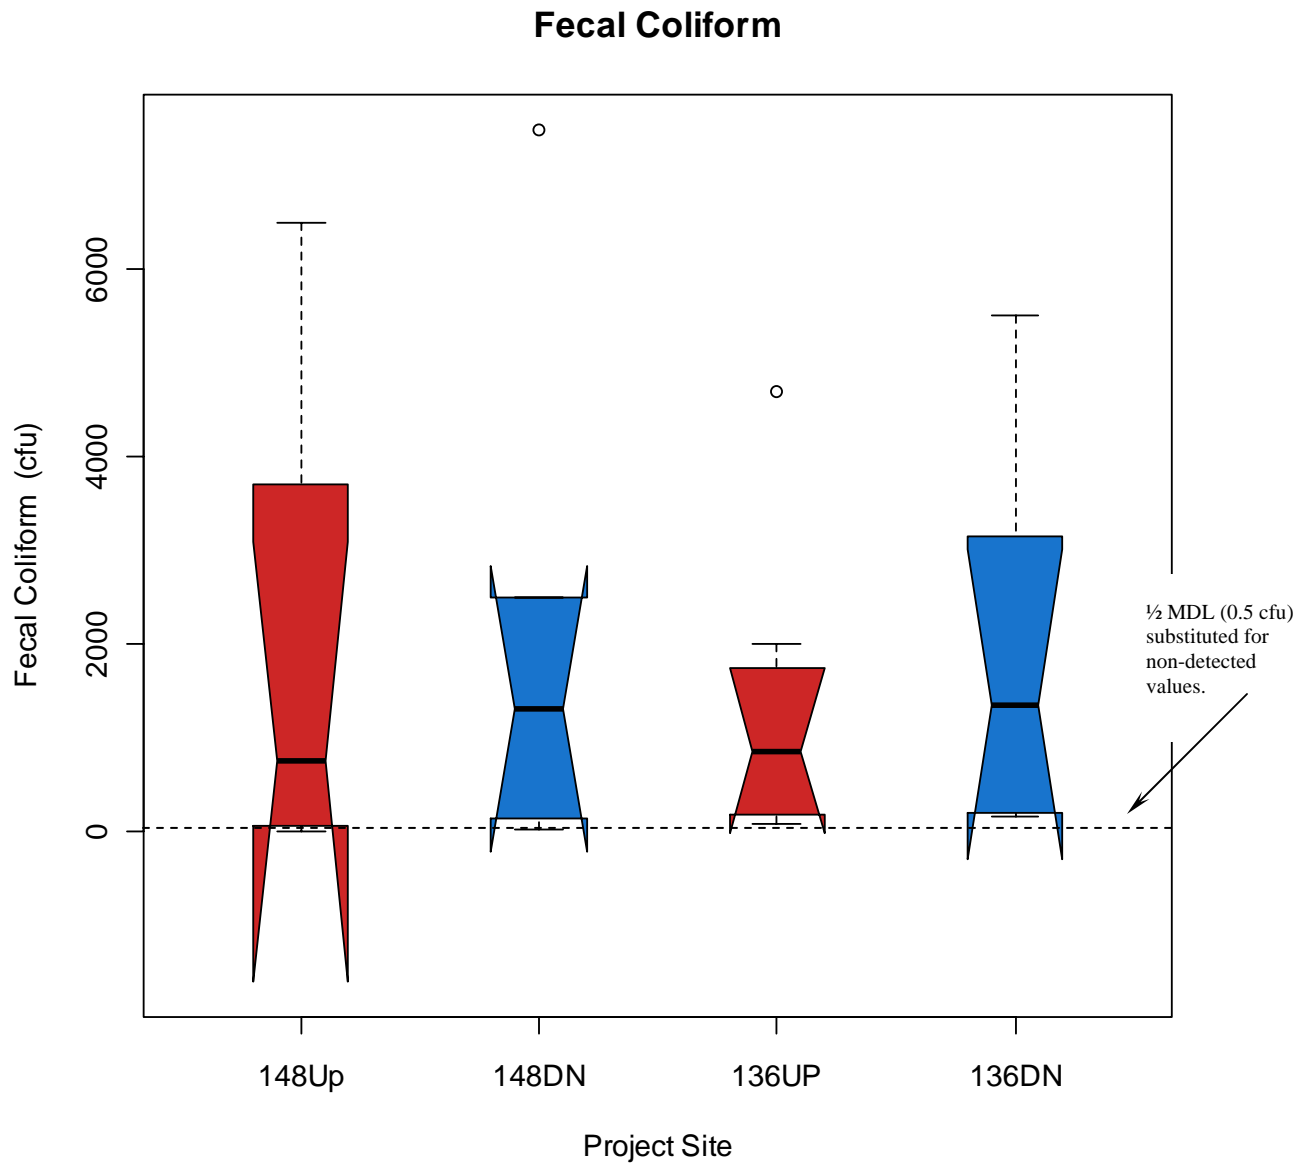
Figure 33. Fecal coliform (cfu)

Fecal coliform results include values reported as below the MDL of 1 cfu. A substitution of 1/2 the MDL (0.5 cfu) was used for values reported at <MDL.

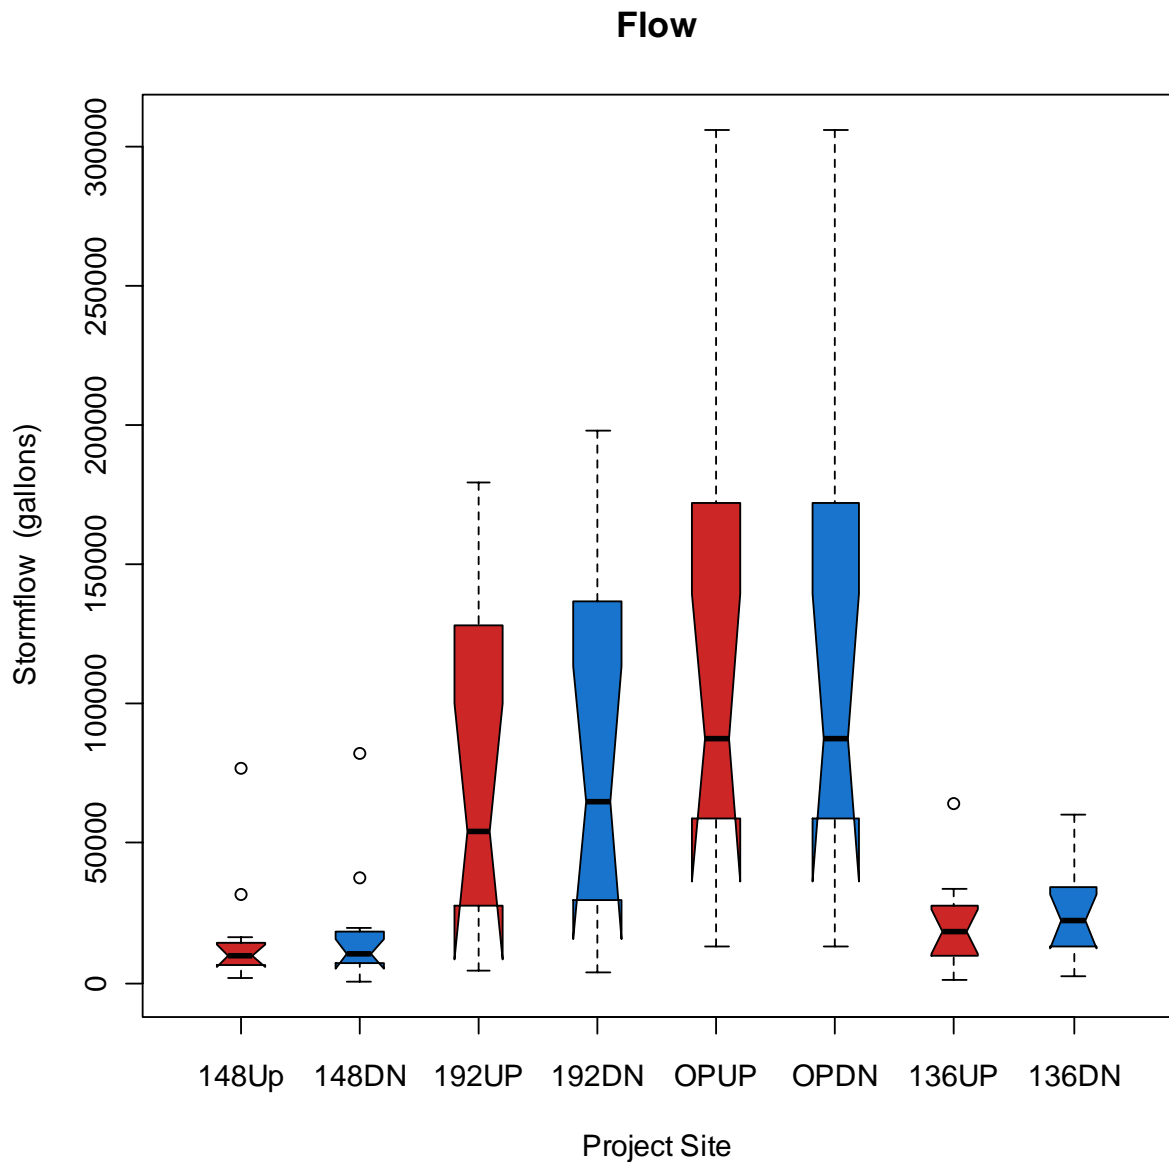
Figure 34. Total Flow During Sampled Storm Events

Box plots demonstrate the range of flows during sampled storm events and provide a comparison of influent to effluent flow during those events. This figure demonstrates the increased downstream flows typical of sampling biased to wet-season storm events where most of the successful sampling events occurred. These flows are not representative of the dry season influent/effluent flow regimes at the ditch project sites.
