BARING BRIDGE #509A

KING COUNTY
LANDMARKS COMMISSION BRIEFING

February 28, 2019

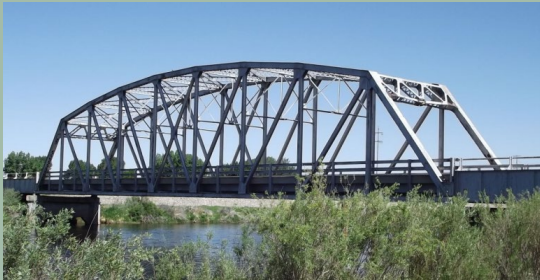
➤ Steel Truss

Structure Alternative 1

Steel Truss Bridge

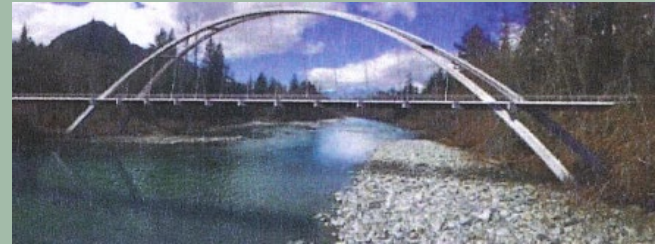
➤ Steel Network Tied Arch

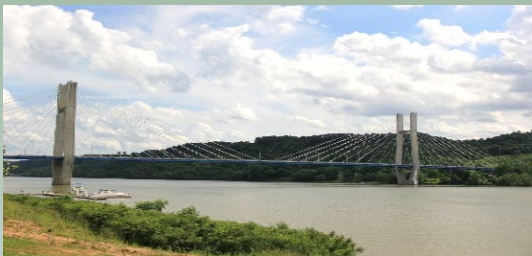
➤ Cable stayed

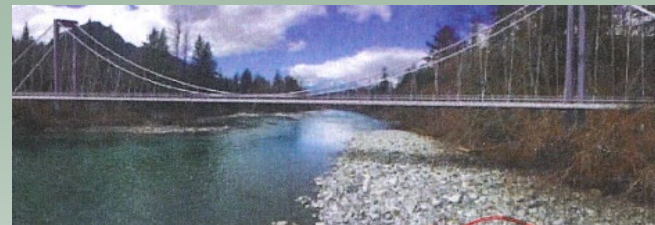
➤ Suspension
