BARING BRIDGE #509A

KING COUNTY
LANDMARKS COMMISSION BRIEFING

October 22, 2020

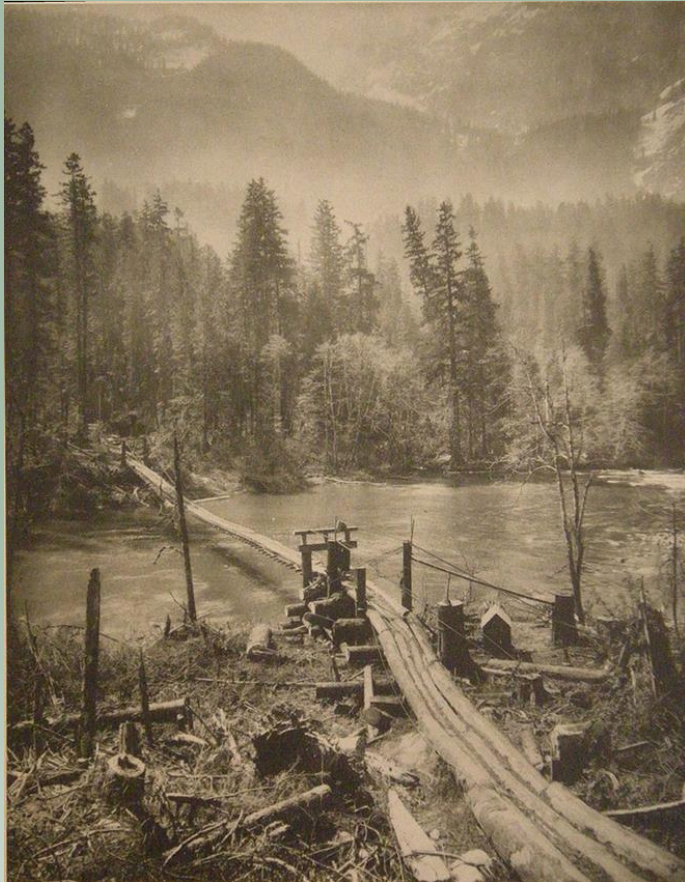
photo taken by Asahel Curtis (~1910)

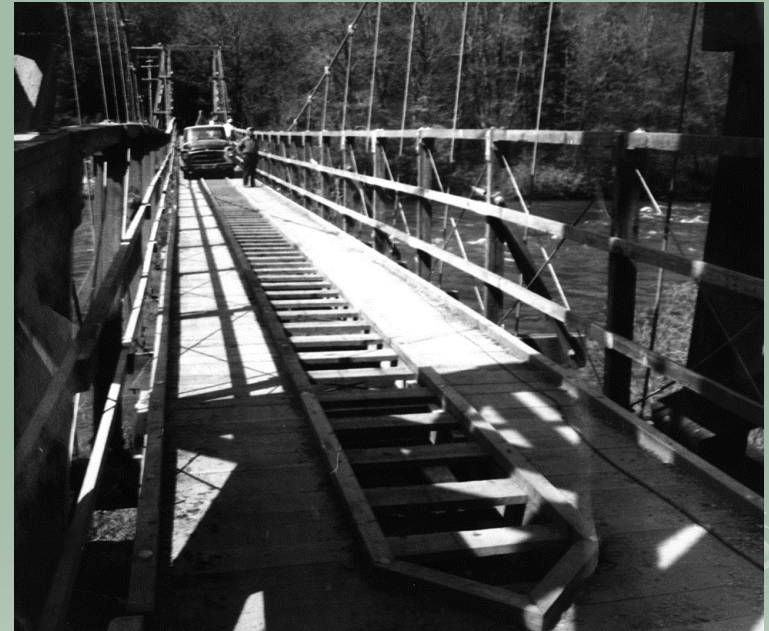
Photo of rail post-repair (1950)

- 1950 Repair of sills, cables and deck
- 1953 Truss stiffened, new decking, new anchorages
- 1958 Timber towers reconstructed
- 1962 Deck replaced
- 1976 Second pair of main cables added and with new anchorages, replaced North approach
- 1984 Floorbeams, stringers, decking, and railings replaced in kind. Suspender rods replaced with cables.
- 1995 Bridge strengthening with new floorbeams, decking, concrete anchors, new high strength hangers, and new bridge rail system.
- 1999 Added steel brackets to tower caps, tower repairs
- 2010 Replaced a column and foundation sills at North Tower
- 2015 Upgraded cable support brackets at the tower caps
- 2017 Emergency repair with replacement of stringers, new decking, steel banding timber floorbeams, and tower timber reinforcement
- 2018 Mudsill repairs at piers 3 and 5
- 2020 Completed a temporary scour repair and tower timber reinforcement

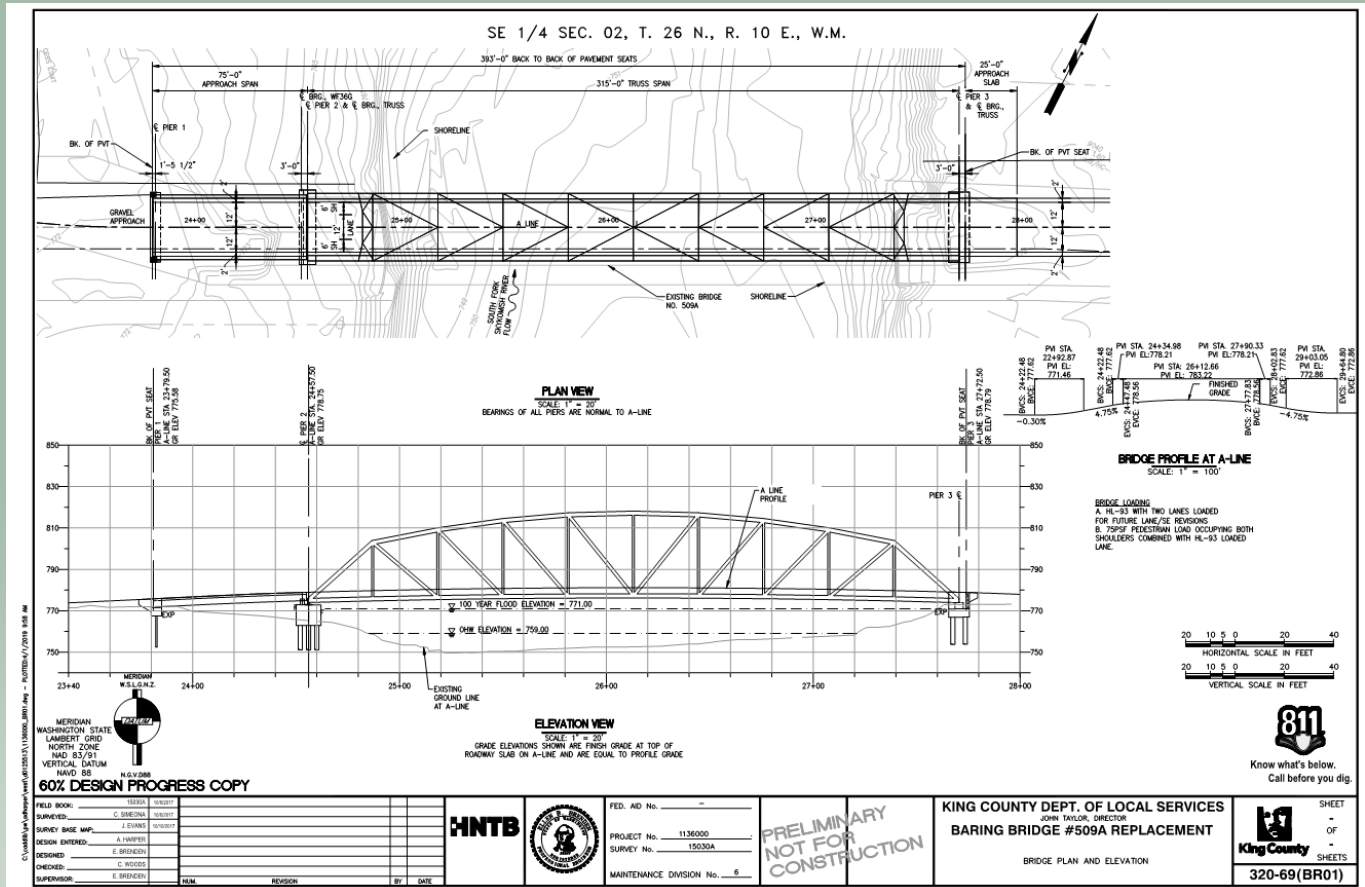
Proposed Bridge Plan and Elevation

- Single lane and pedestrian facilities on Bridge with potential to reconfigure to 2 lanes
- Two lanes on approaches
- Clearance over flood plain
- Designed to meet all legal loads
